## **Fuel Icing – Trent 800-Powered 777 Airplanes**

This document provides information on fuel icing and how it occurs, information on the events, corrective action, and why corrective action is not being considered for 777 airplanes powered by GE90 or PW4000 engines. It is intended as background information for airline engineering and flight operations engineering departments and is intended only to complement the previously released AAIB, NTSB, Boeing and Rolls-Royce reports and communications.

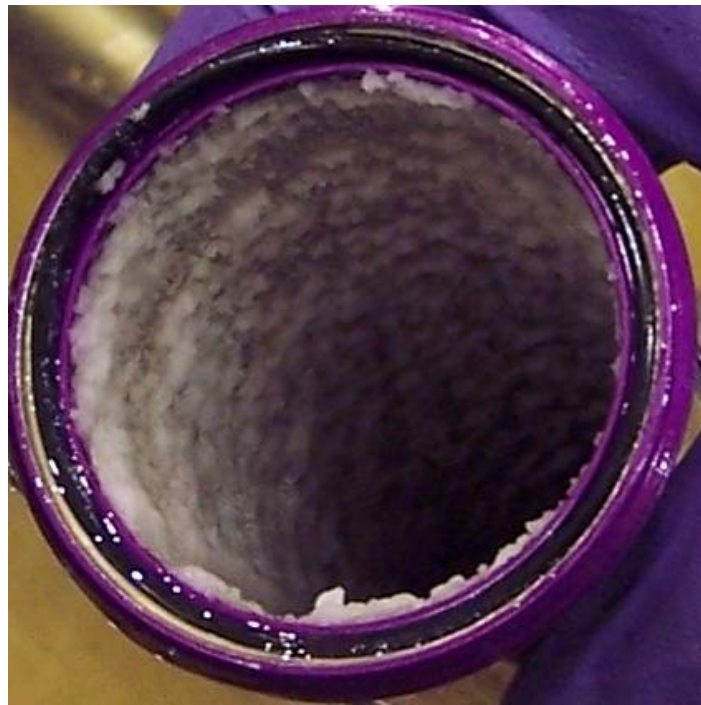
The investigation into the January 2008 accident and the subsequent November 2008 single engine rollback event has established that it is possible for sufficient ice to build up within the fuel feed system, such that it's sudden release would cause a restriction at the face of the Fuel Oil Heat Exchanger (FOHE). The AAIB Interim Report 2 concluded that the most likely scenario for the accident flight was that ice formed on the inside of the fuel feed tubes. Testing has shown that ice can form around the internal circumference of the tubes (ice formation is similar to plaque or scaling on the internal circumference of a household water pipe) as shown in Figure 2a. It is considered that, in the later stages of the approach, the engine accelerations, and perhaps a combination of other factors such as turbulence, aircraft pitch changes and an increase in the strut temperature, could have contributed to a sudden release of soft ice in the fuel feed system for both engines. This ice would have travelled through the fuel feed pipes, where it could have formed a restriction on the face of the FOHE sufficient to cause the subsequent engine rollbacks.

Figure 2a Ice forming inside the fuel system tubing

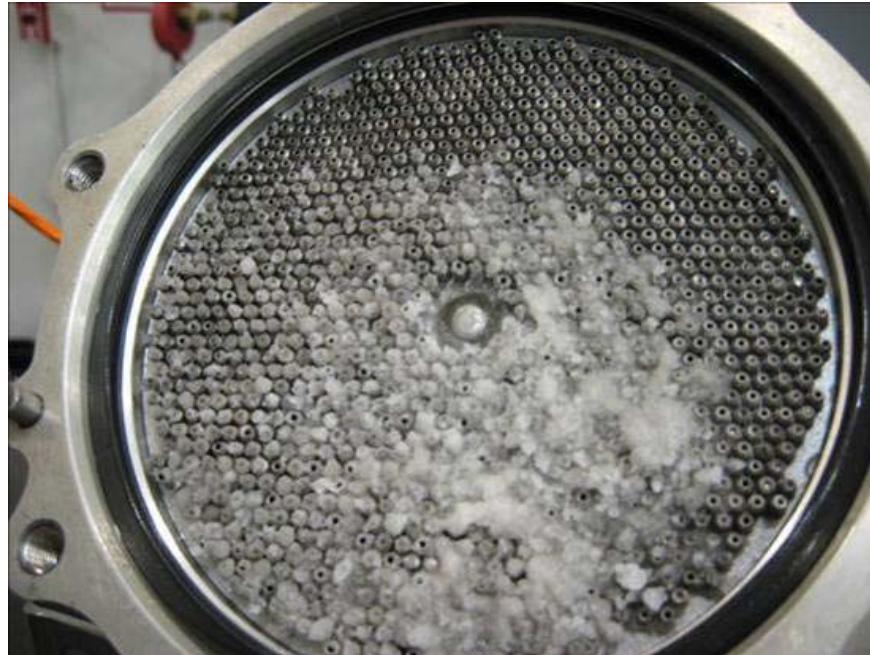
Figure 2b shows ice accumulation on the inlet of the FOHE (from laboratory testing at Boeing's fuels lab). Testing has identified that the current FOHE can become blocked by soft ice and that a fuel restriction can result at fuel tank temperatures of -15°C and below.

Figure 2b – Ice Accumulation on Inlet to FOHE

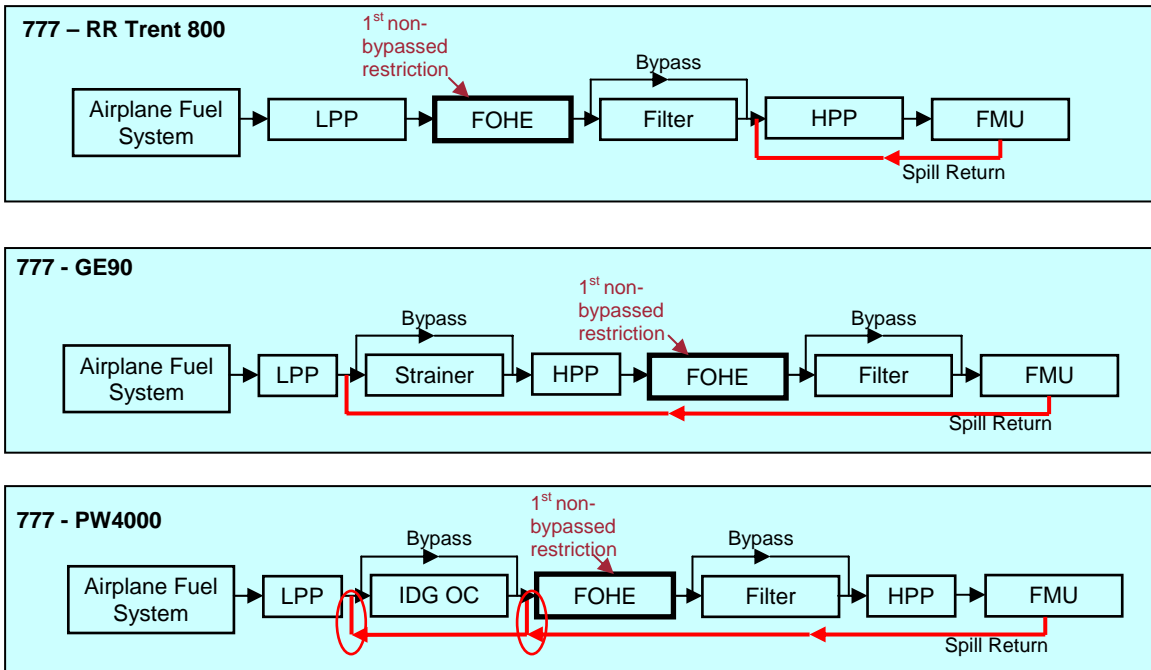
On the Trent 800 engine the spill flow is reintroduced downstream of the FOHE resulting in fuel from the fuel tank hitting the face of the FOHE without any significant heat addition. On both the PW4000 and the GE90 engines, the warm spill flow is reintroduced upstream of the FOHE resulting in much warmer fuel hitting the face of their heat exchangers. As shown in Figure 3, the PW4000 engine's IDG Oil Cooler could act as the first restriction point if ice is released upstream. However, this component includes a bypass valve that permits uninterrupted fuel flow should the primary flow path become obstructed. Similarly, the GE90 fuel system includes a strainer, which could act as the 1st restriction point. Although this component is located upstream of the spill return, the bypass valve again permits uninterrupted fuel passage should a restriction occur. Consequently, the opportunity for fuel flow restriction due to ice accumulation on the face of the FOHE is comparatively less for the PW4000 and GE90 engines and Boeing has determined that no action is required to address fuel icing on PW4000- and GE90-powered 777 airplanes.

Figure 3 – Comparison of FMV Spill Flow Return for 777 Engine Types (LPP-Low Pressure engine fuel Pump, HPP-High Pressure engine fuel Pump, FOHE-Fuel Oil Heat Exchanger, FMU-Fuel Metering Unit, IDG OC-Integrated Drive Generator Oil Cooler)

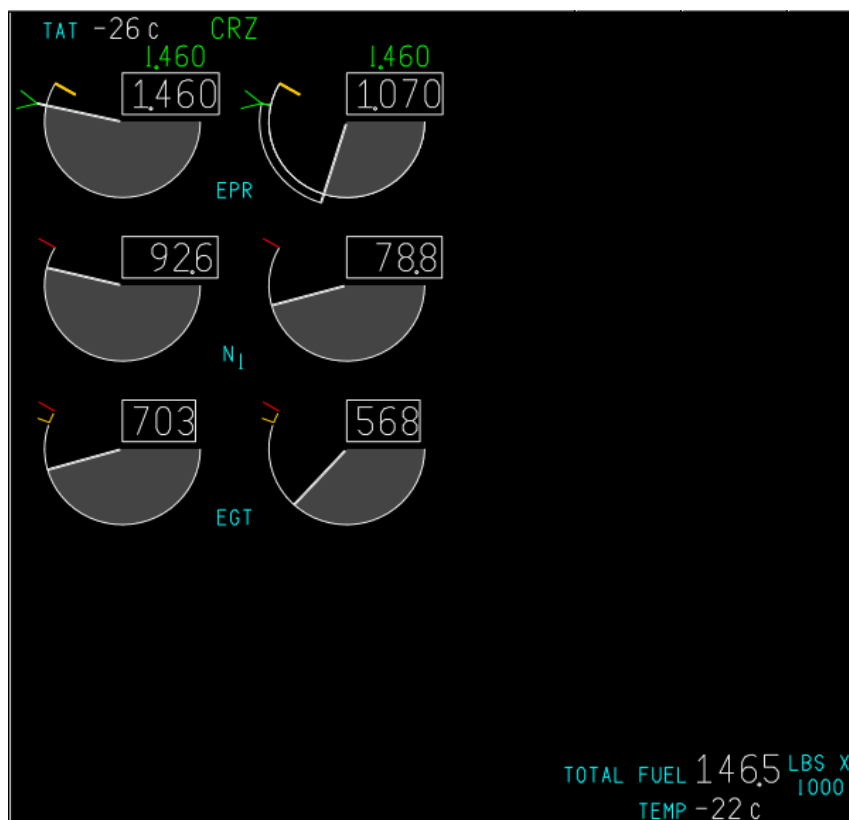
The EICAS display for a single (right) engine thrust roll back event is illustrated in Figure 4a below. The most obvious characteristic is that the indicated (or actual) EPR will drop below the commanded level, causing a large command EPR arc sector to appear on the EPR indicator of the affected engine. Although this large EPR command sector (or shortfall between commanded EPR and indicated EPR) is typical of any scenario where the EEC is commanding a higher EPR than the engine is actually delivering (including normal engine transient conditions where a higher thrust has been commanded but the engine is still spooling up), a fuel icing event will be evident due to the persistence of the large command sector (i.e. a standing command arc) and the magnitude of the EPR shortfall even with the thrust levers remaining stationary. Periodic fluctuations (every 20-30 seconds) in indicated EPR may also be seen.

Figure 4a – Primary EICAS Display (Fuel Icing Scenario, Right Engine)

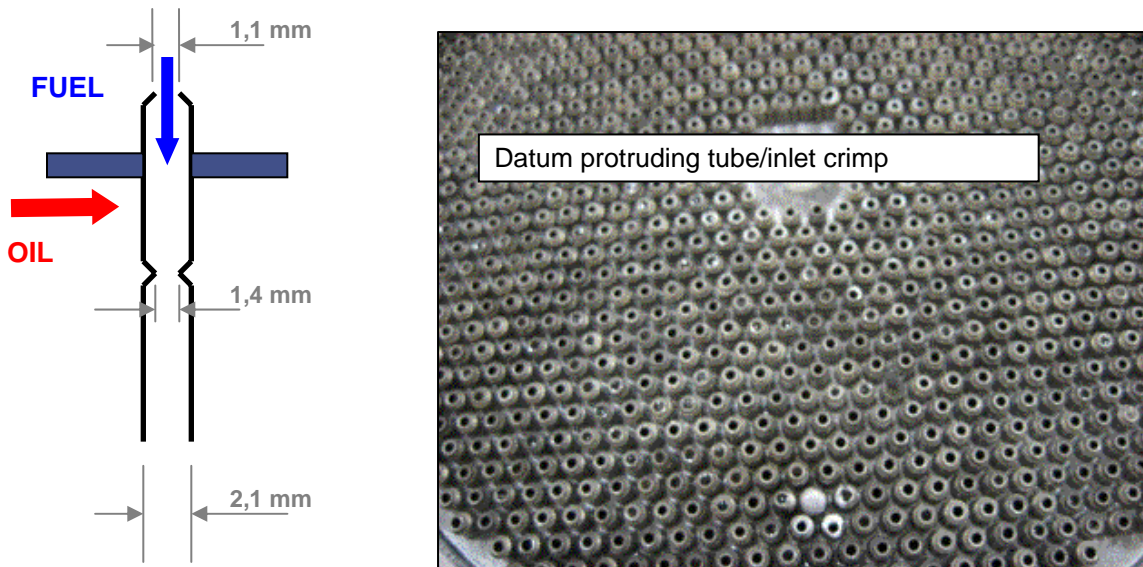
Testing has shown that the current FOHE is susceptible to ice accumulation at the inlet due to the protrusion of the heat transfer tubes from the end plate surface and inlet crimps on the heat transfer tubes (see Figure 5).

Figure 5 – Current Production Standard of FOHE

Boeing and Rolls-Royce have worked with the FAA and EASA to certify a redesigned FOHE that demonstrated a significantly more robust capability to handle ice released from the fuel system. The redesigned FOHE incorporates changes to make the heat transfer tubes flush with the end plate surface and to remove the inlet crimps (see Figure 6). Testing has demonstrated that the redesigned FOHE can withstand a soft ice release event at fuel temperatures below -44 deg C.

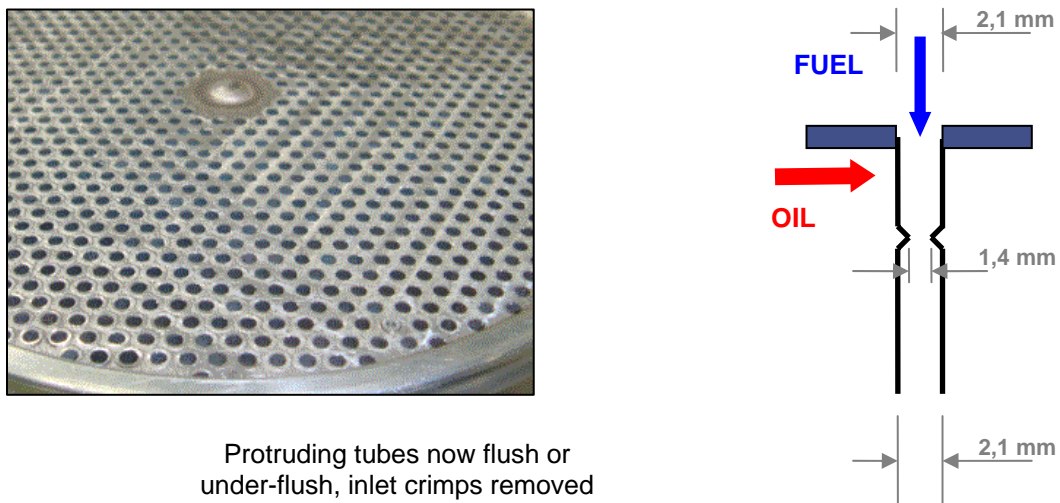
Protruding tubes now flush or under-flush, inlet crimps removed

Figure 6 – Proposed FOHE Redesign

Following European certification of the redesigned FOHE for the Trent 800 engine by EASA, the FAA certified the redesigned FOHE on July 9, 2009 for use on the 777. On 13 July, 2009, EASA issued an airworthiness directive (AD) mandating the installation of the new FOHE on the Trent 800 engine (AD No.: 2009 – 0142). It is expected that FAA will adopt this AD for US 777 operators. The EASA AD requires all Trent 800 engines be upgraded before 1 January, 2011 or within 6000 flight hours beginning 10 July, 2009, whichever occurs first.

The new FOHE is incorporated on in-service airplanes by Rolls-Royce Service Bulletin 79-AG257 dated 24 June 2009 (published 10 July 2009) and Boeing Service Bulletin 777-72A0030, dated 10 July 2009.
