## **Fuel Icing – Trent 800-Powered 777 Airplanes**

This document provides information on fuel icing and how it occurs, information on the events, corrective action, and why corrective action is not being considered for 777 airplanes powered by GE90 or PW4000 engines. It is intended as background information for airline engineering and flight operations engineering departments and is intended only to complement the previously released AAIB, NTSB, Boeing and Rolls-Royce reports and communications.

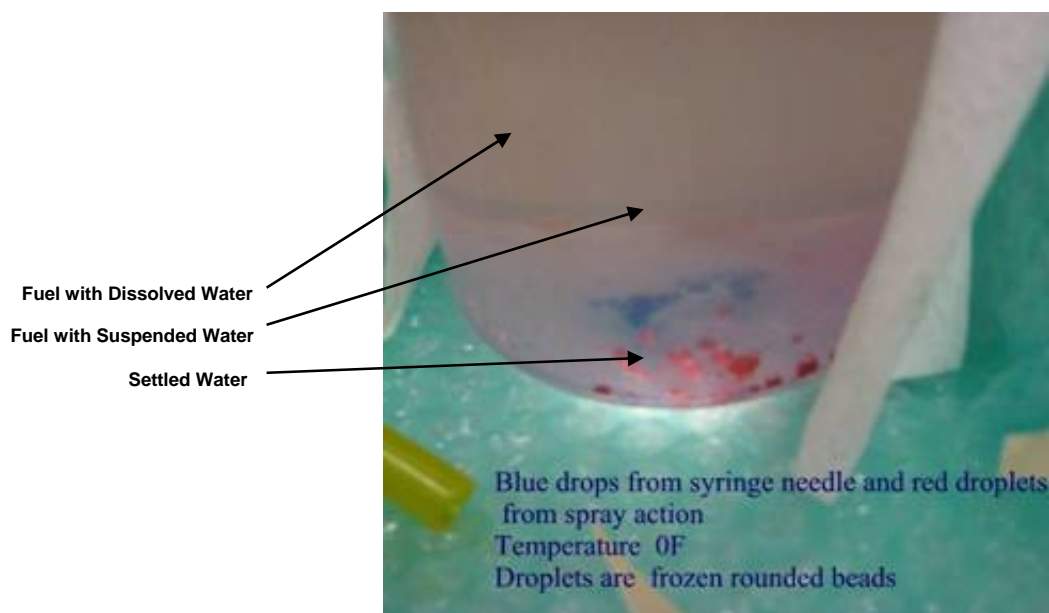
For a 777-200 or -300 airplane with full left, right and center tanks, the typical expected amount of dissolved and suspended free water (assuming a typical concentration in uploaded fuel of 70ppm) in a fuel load would be on the order of 7 liters. Figure 1 shows water in a fuel sample from the Boeing laboratory showing dissolved, suspended and settled water. Dissolved water at any concentration level cannot be seen; the fuel is clear and bright. Suspended free water at concentrations below 30ppm is also clear; above that concentration the fuel becomes hazy.

Figure 1 – Fuel Sample showing dissolved, suspended free water and settled free water

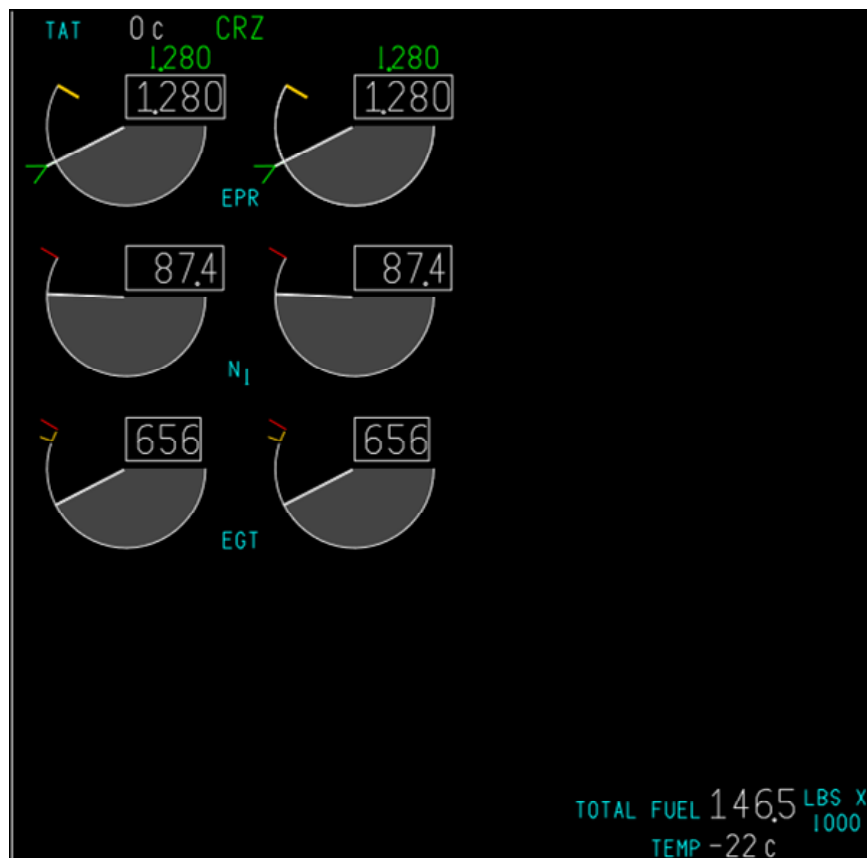
The mismatch between indicated and commanded EPR can differentiate this event from that of a blockage of the airplane TAT or engine probes due to probe icing or debris in the probe. In that case, the EEC is presented with incorrect temperature data and limits the commanded EPR to a lower value. The engine responds in kind, and the indicated EPR matches the commanded EPR. The EICAS display for a TAT probe icing event affecting both engines is illustrated in Figure 4b below.

Figure 4b – Primary EICAS Display (TAT Failure Scenario, dual engine)
